NASA CR-241

**OPERATION OF A FORCED CIRCULATION,
HAYNES ALLOY NO. 25, MERCURY LOOP
TO STUDY CORROSION PRODUCT
SEPARATION TECHNIQUES**

by David B. Cooper

Prepared under Contract No. NAS 5-462 by
THOMPSON RAMO WOOLDRIDGE, INC.
Cleveland, Ohio
for

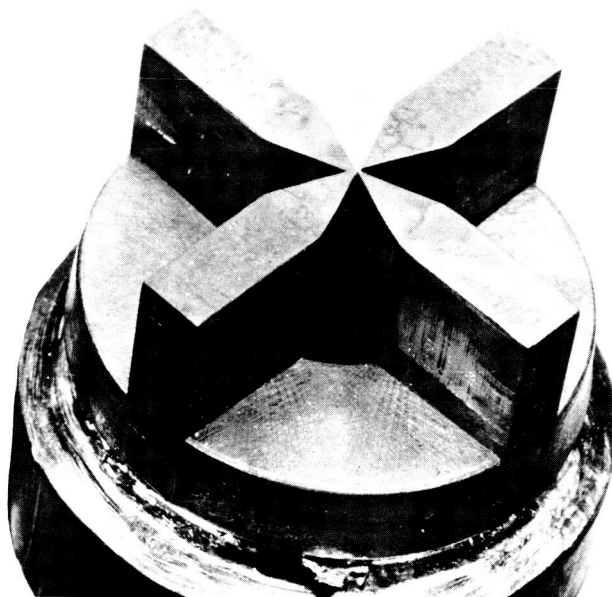
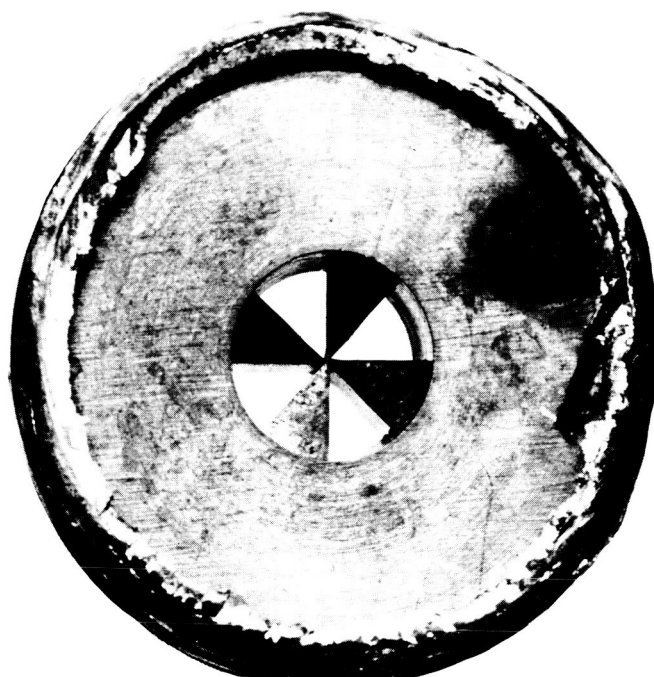
Figure 17. Deposit Found in Loop Nozzle.

The nozzle was also observed to contain a deposit, as shown in Figure 17. Although there was a small amount of deposition on the inlet side, the majority of the deposit was found on the outlet.

a) Inlet

b) Outlet

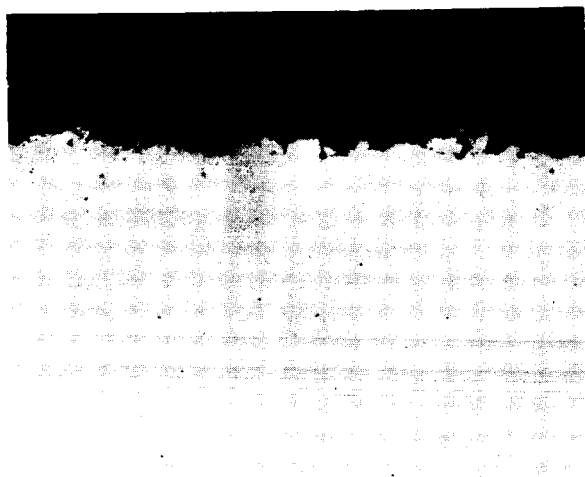
a) Section 5, TC 14
Weld; Superheater Inlet
(Layer Attack)

b) Section 5, TC 14
Superheater Inlet
(Layer Attack)

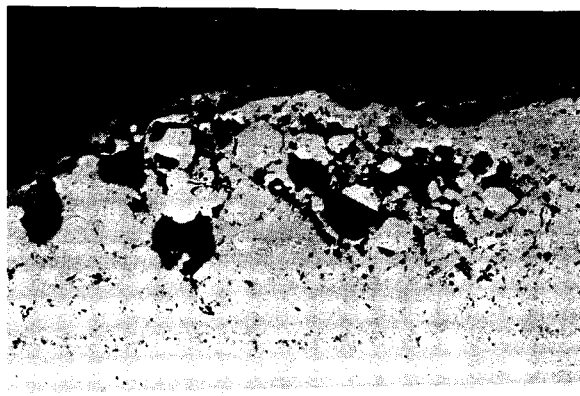
a) Section 2, TC 25
Superheater Mid-Section
(Crevice Attack)

b) Section 1, TC 27
Superheater Outlet
(Deposition)

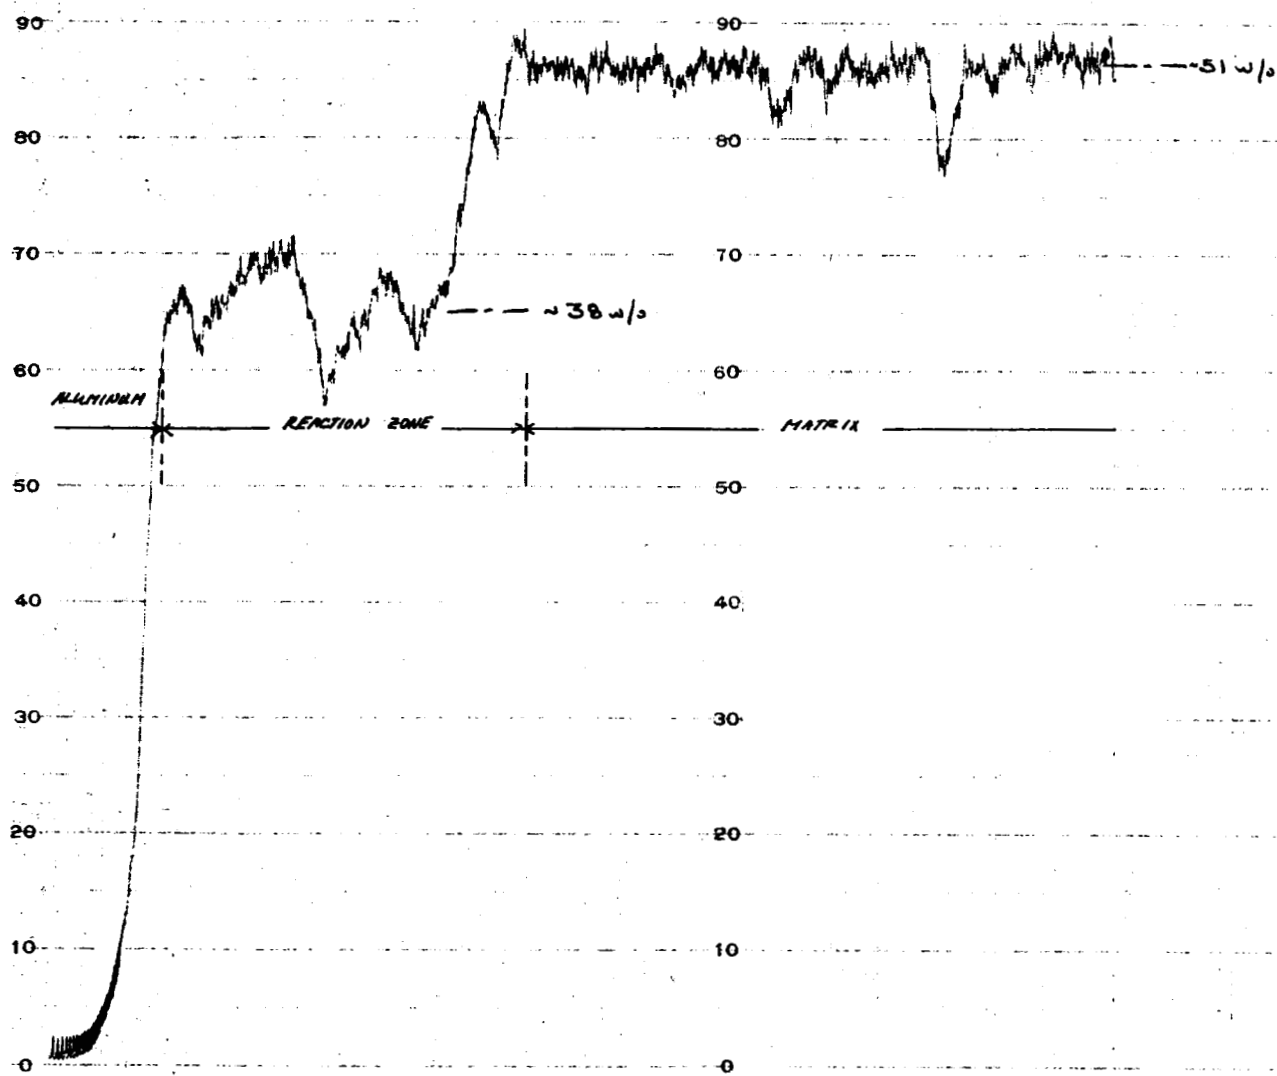
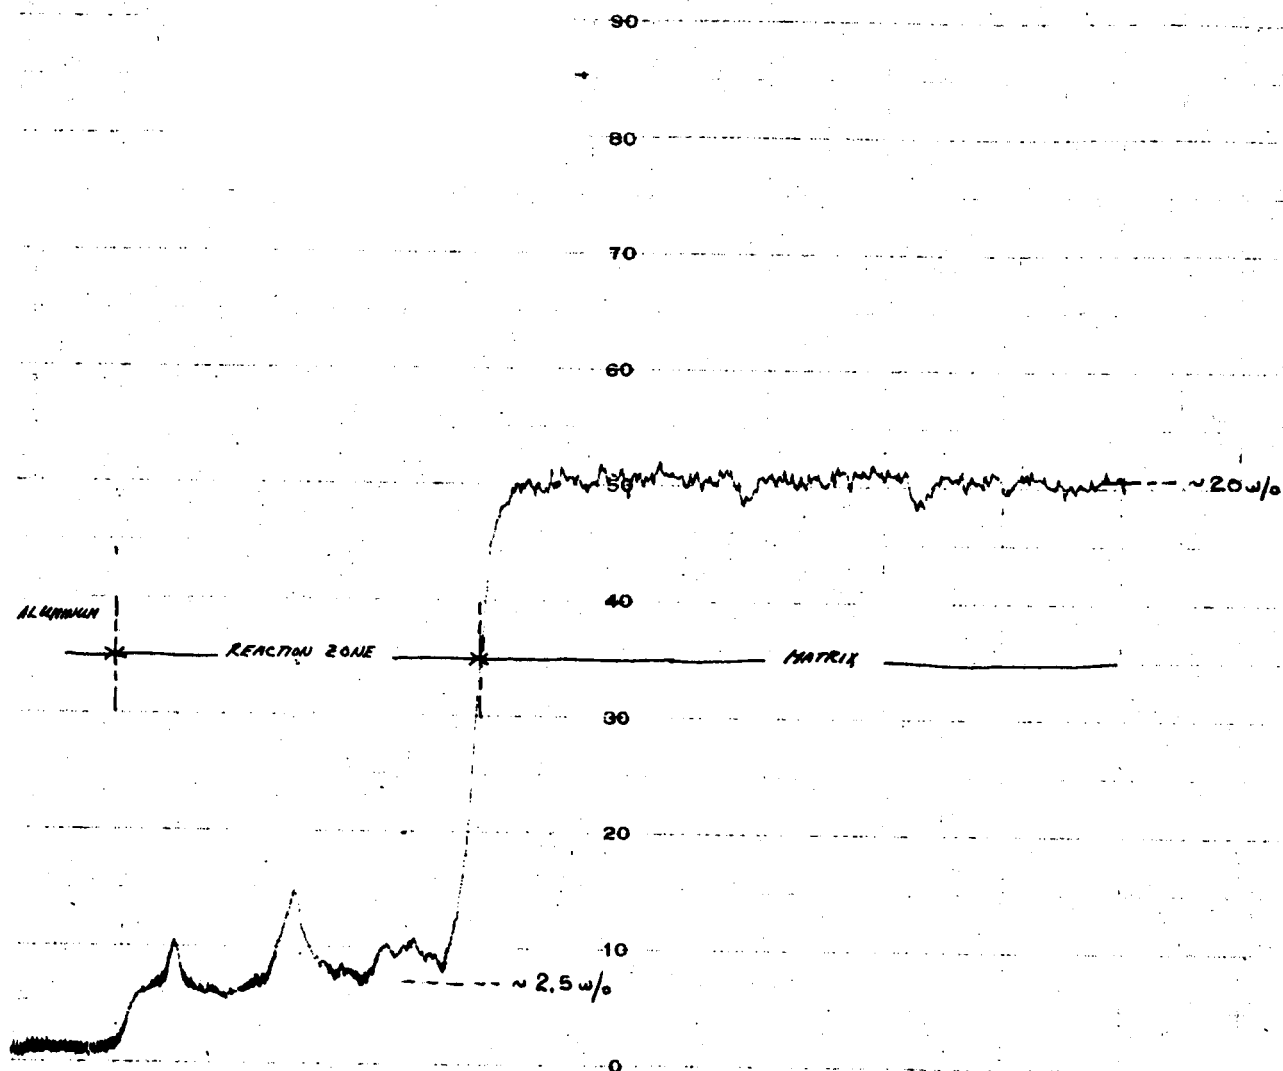
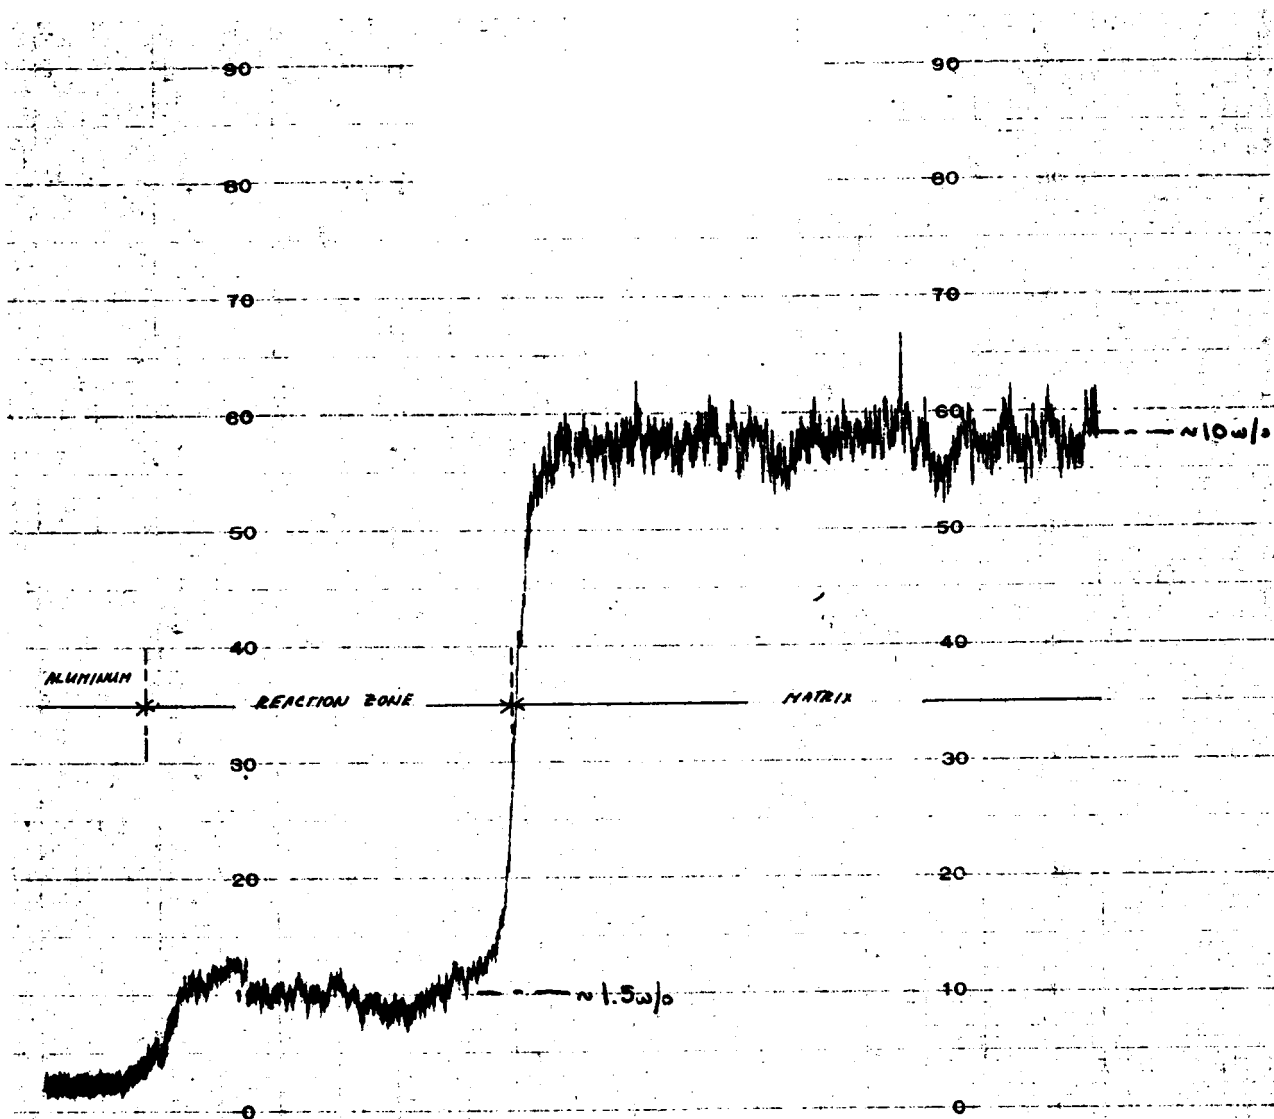
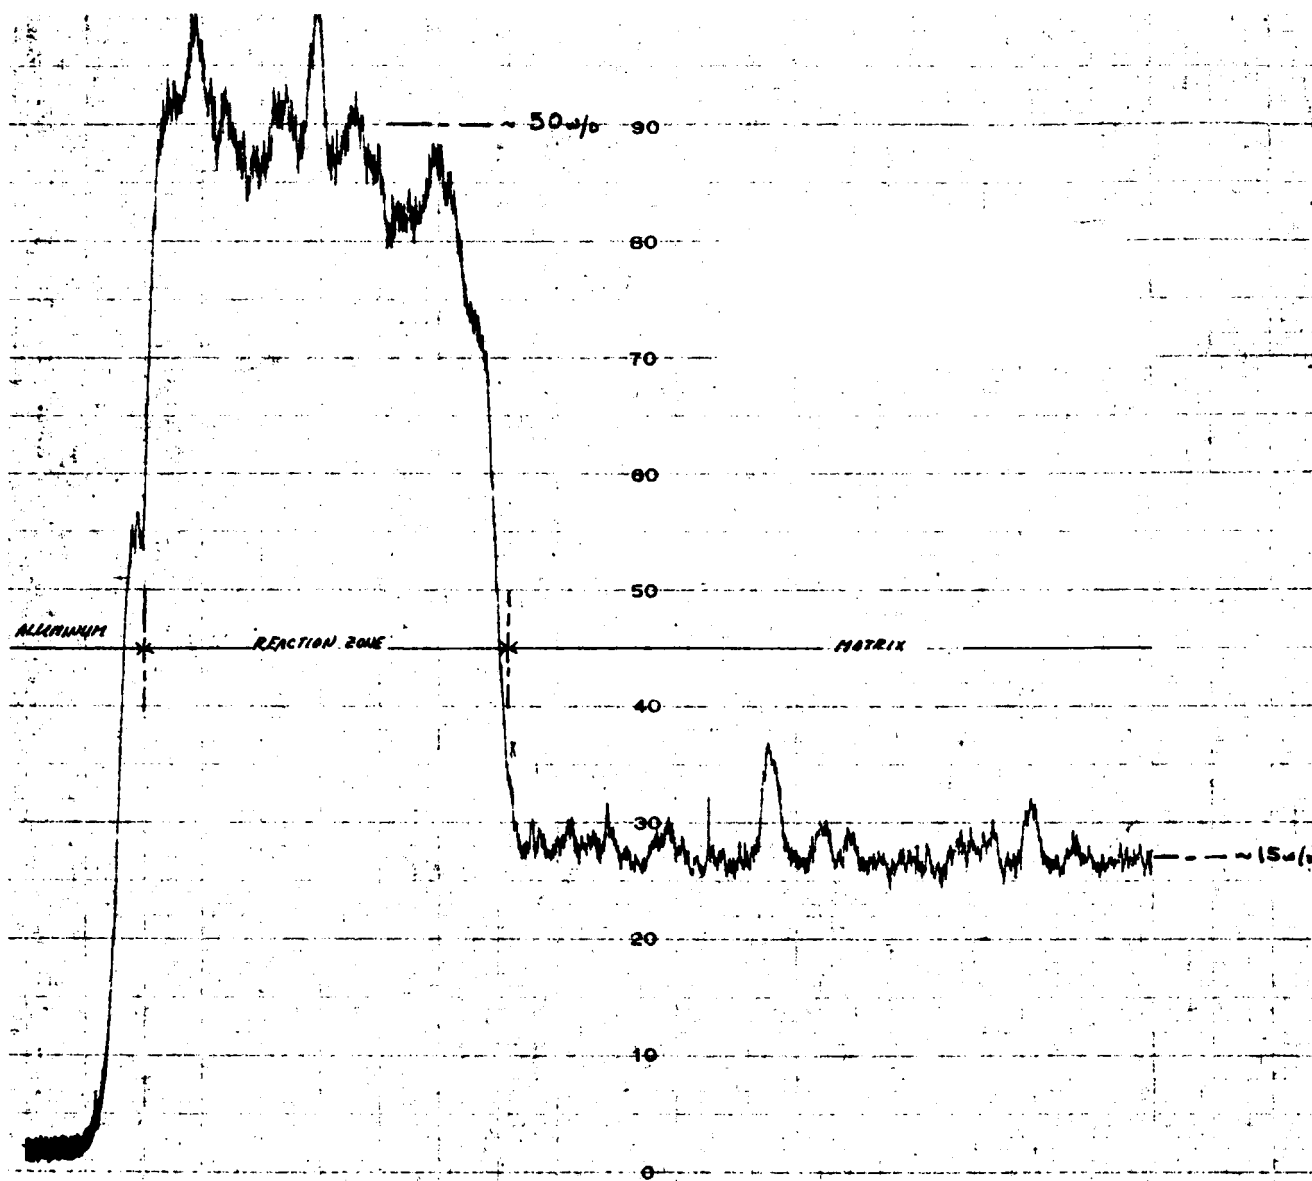
As seen in Figures 31 through 34, the electron beam microanalysis on the pre-heater outlet specimen (see Figure 20b) revealed a leached layer with an abrupt concentration discontinuity approximately 40 to 45 microns from the surface. The corrosion layer was found to be enriched in tungsten and depleted in nickel, chromium, and cobalt. Zirconium was found in the matrix as tungsten-zirconium carbides and comprised less than 0.05 percent. The zirconium concentration rose to 0.05 to 0.08 percent in the corrosion layer; however, the background intensity also rose as a result of the increased tungsten content. The titanium and columbium concentrations were consistently less than 0.05 percent.

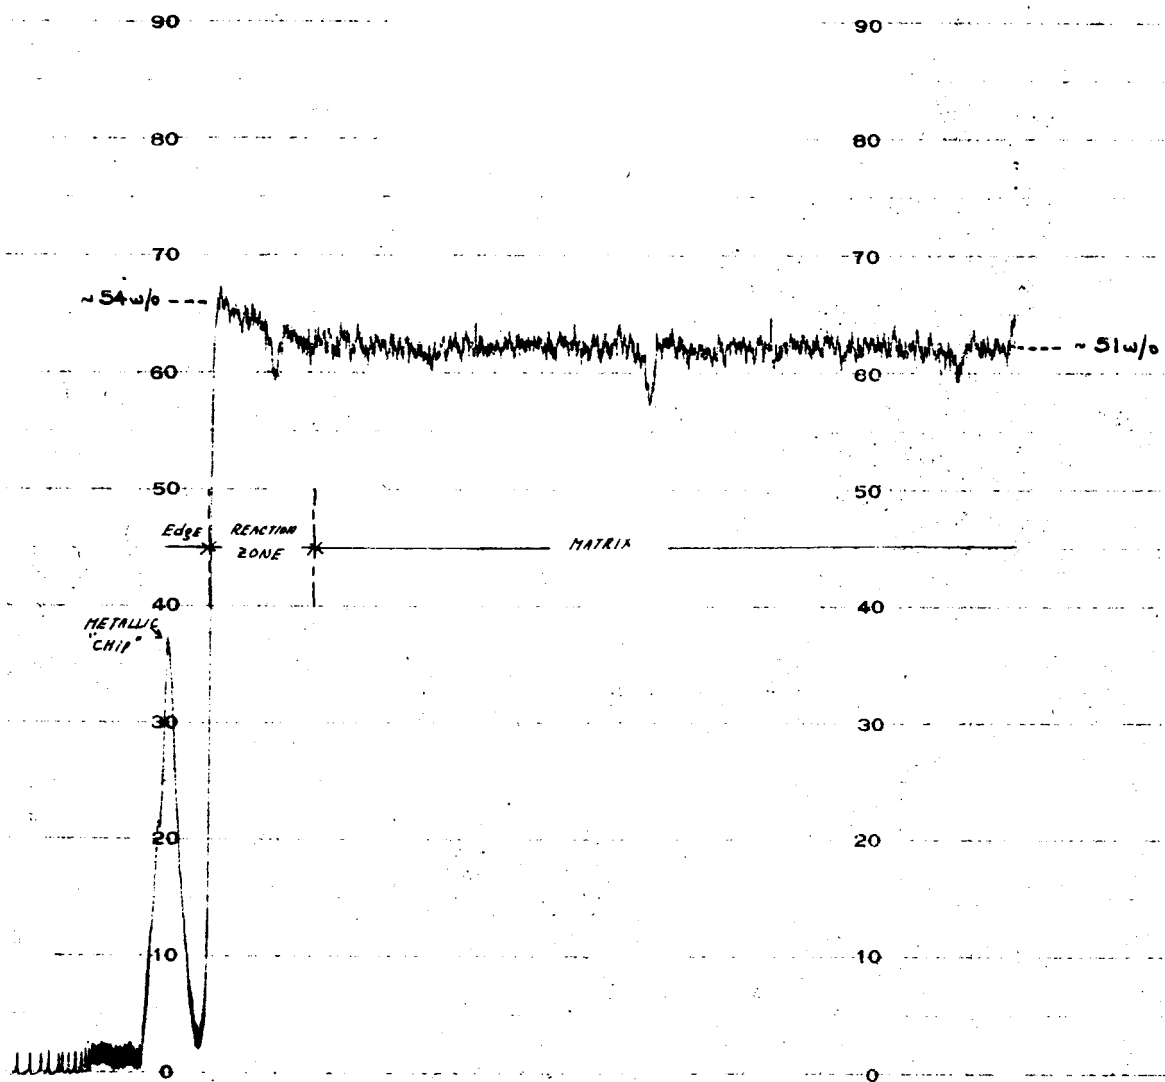
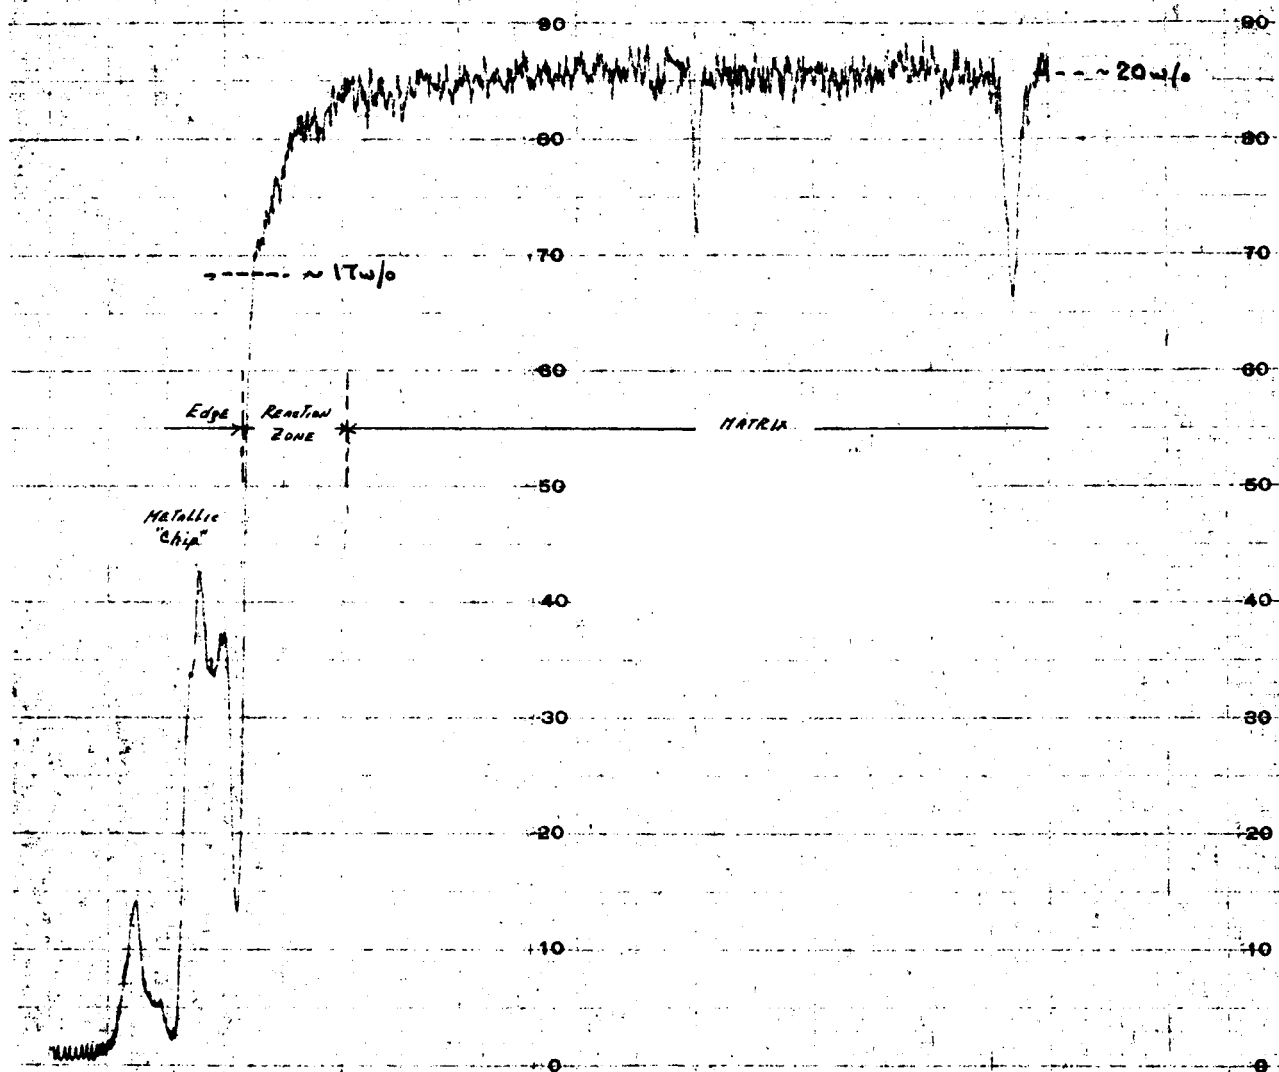
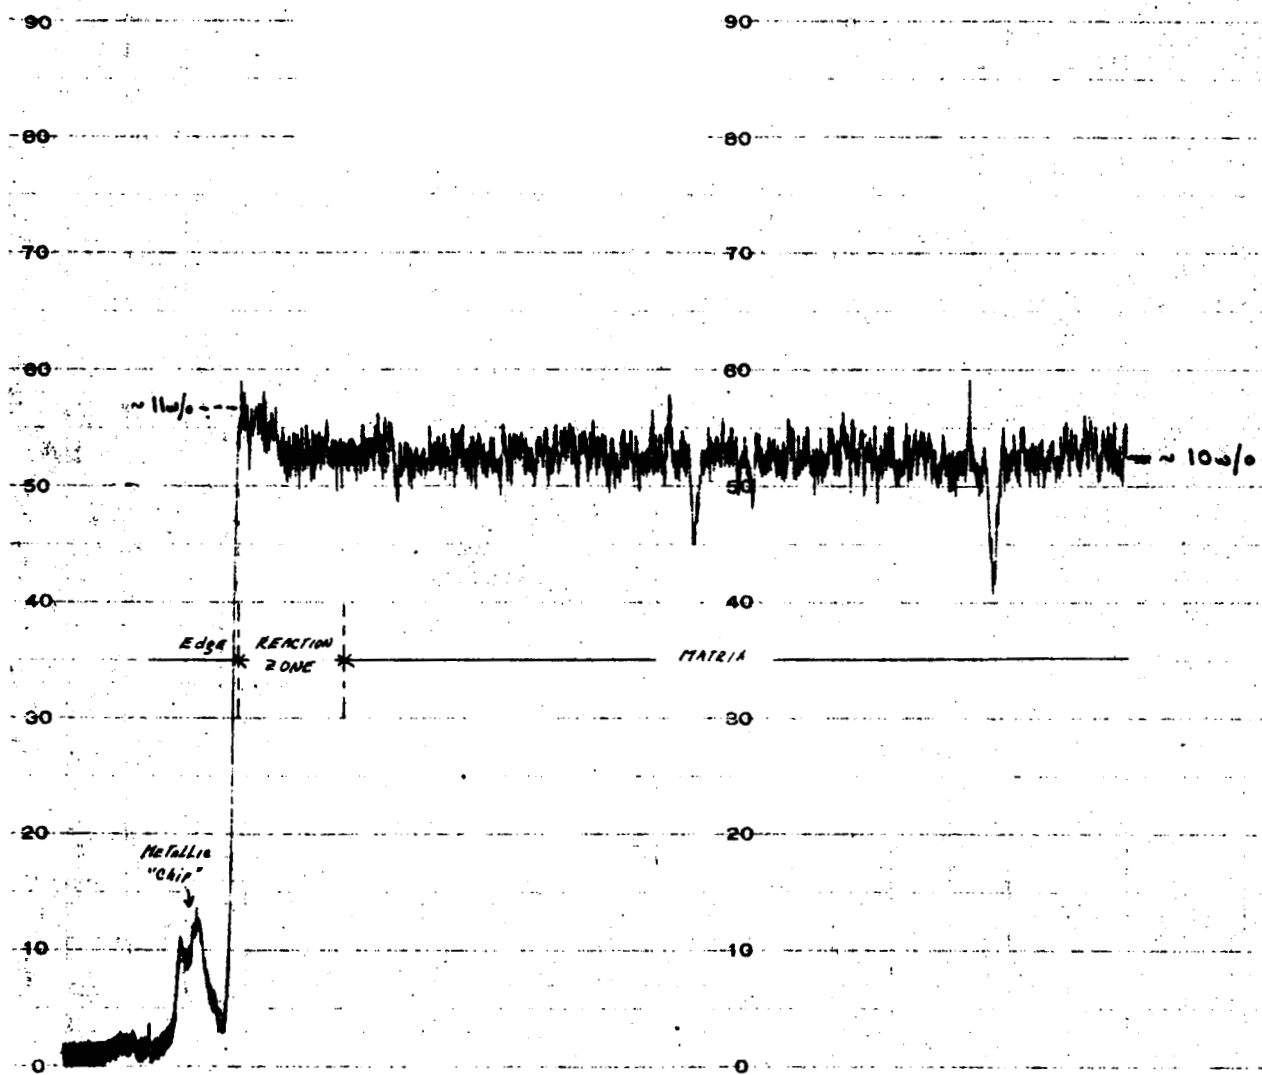
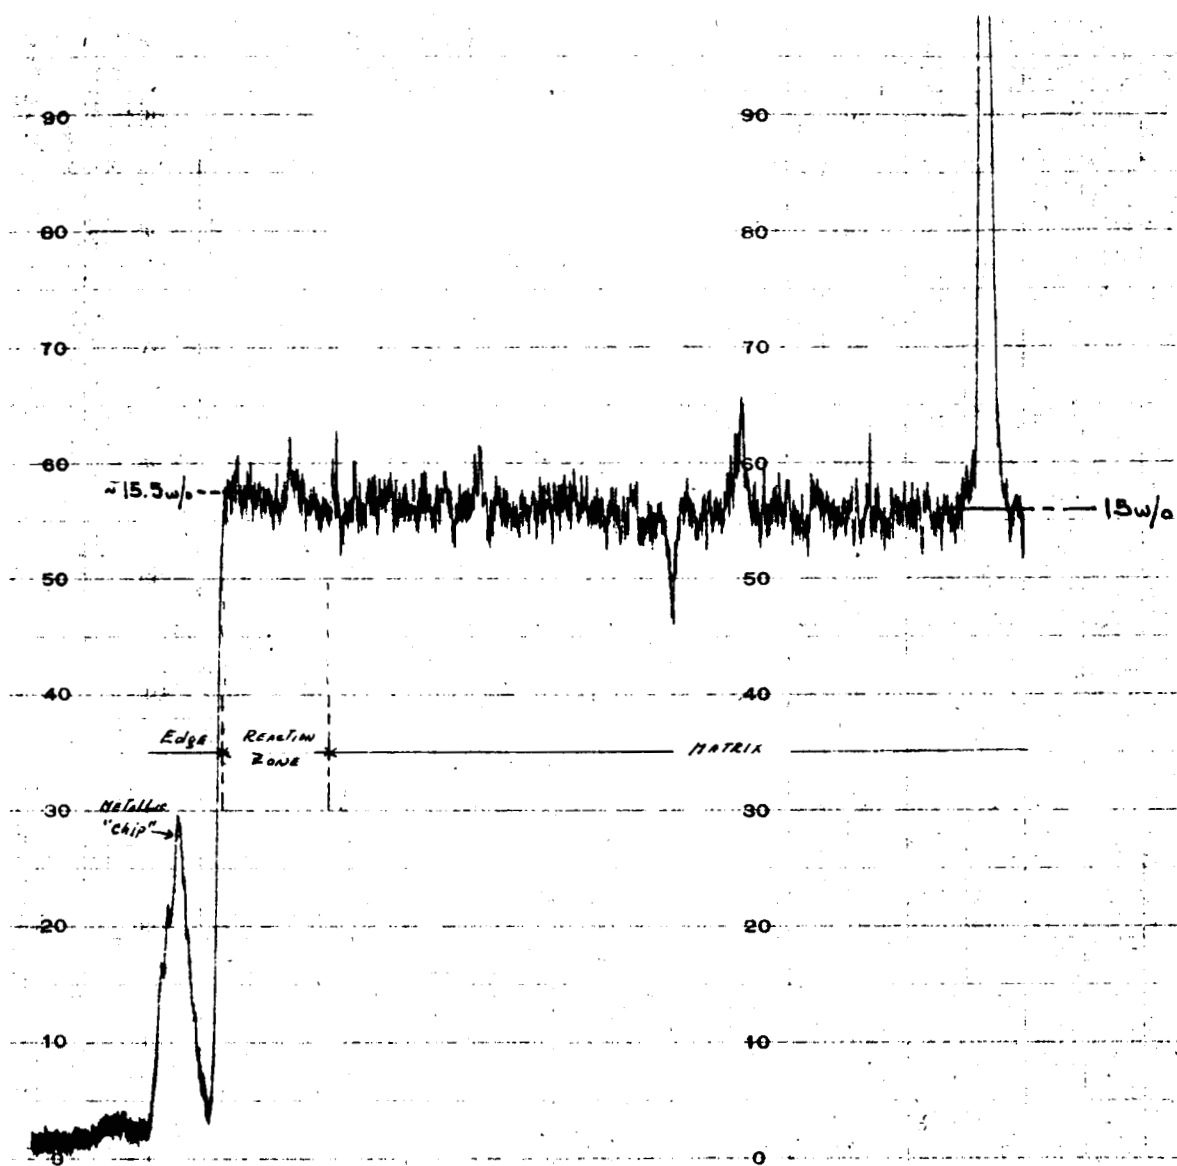
The condenser outlet specimen (see Figure 22d) revealed no visible evidence of a surface chemistry change. However, the concentration distributions (Figures 35 through 38) showed the presence of a slowly varying gradient to a depth of 25 to 30 microns. Cobalt, nickel, and tungsten showed an increase at the I.D. surface of the specimen, while chromium was found to be depleted. A small metallic chip, partially buried in the mount material, was included in the traverse. This chip was the only one noted in the area selected for analysis and is considered insignificant. Except for some zirconium in the matrix tungsten-zirconium carbides, the zirconium, titanium, and columbium concentrations were consistently less than 0.05 percent.

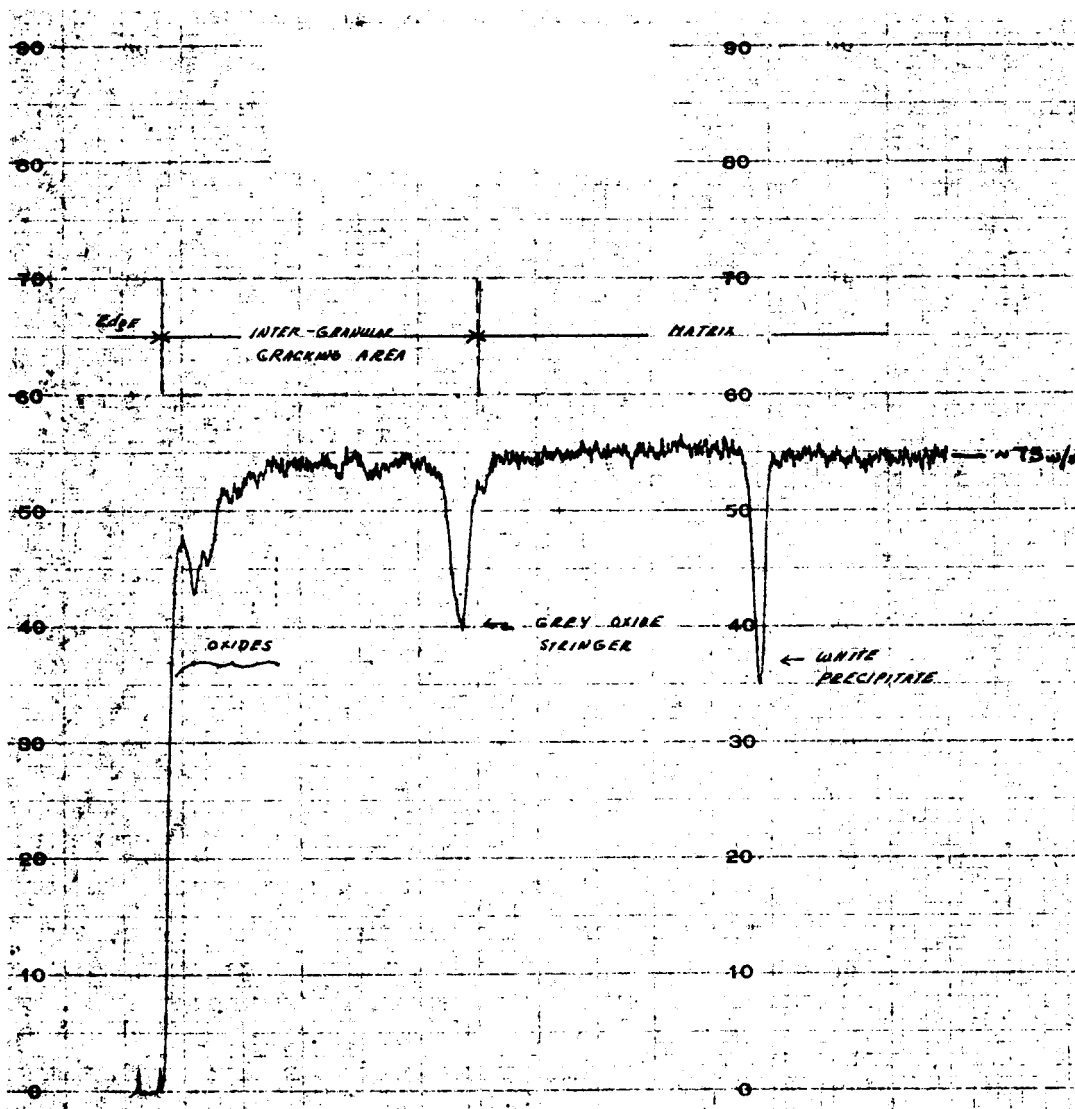
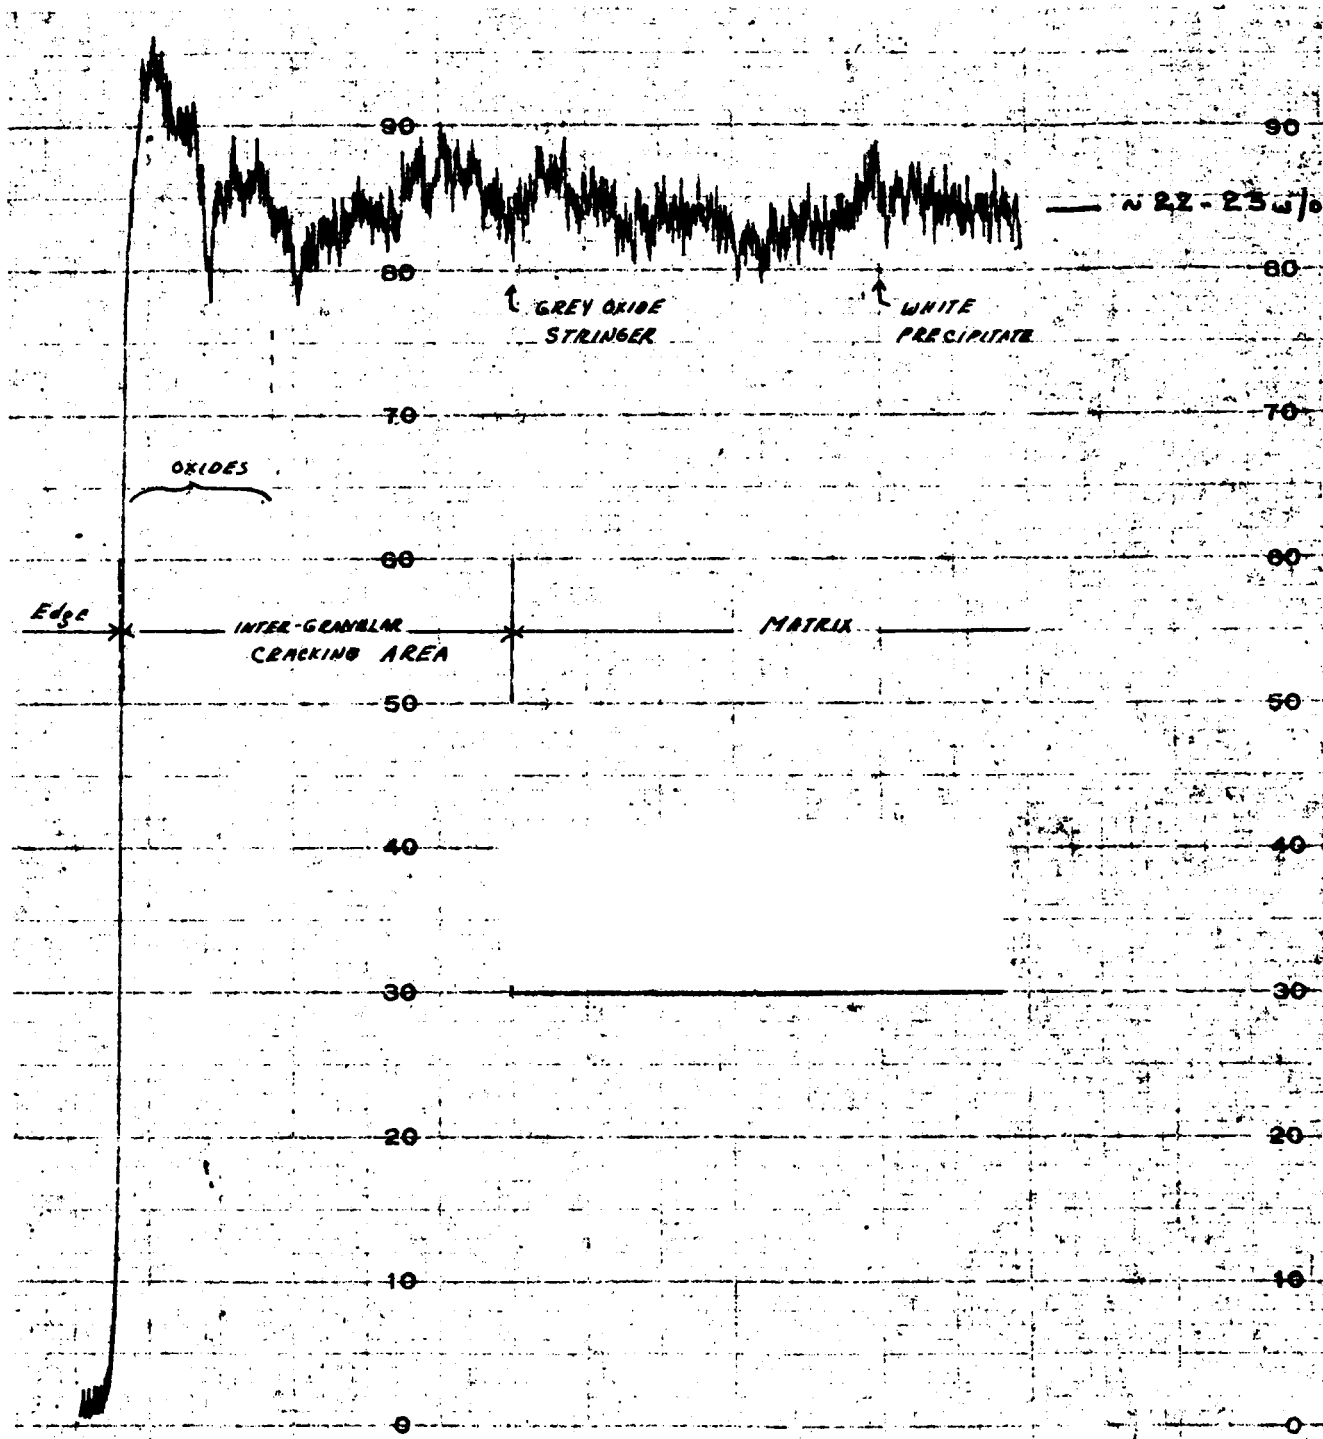
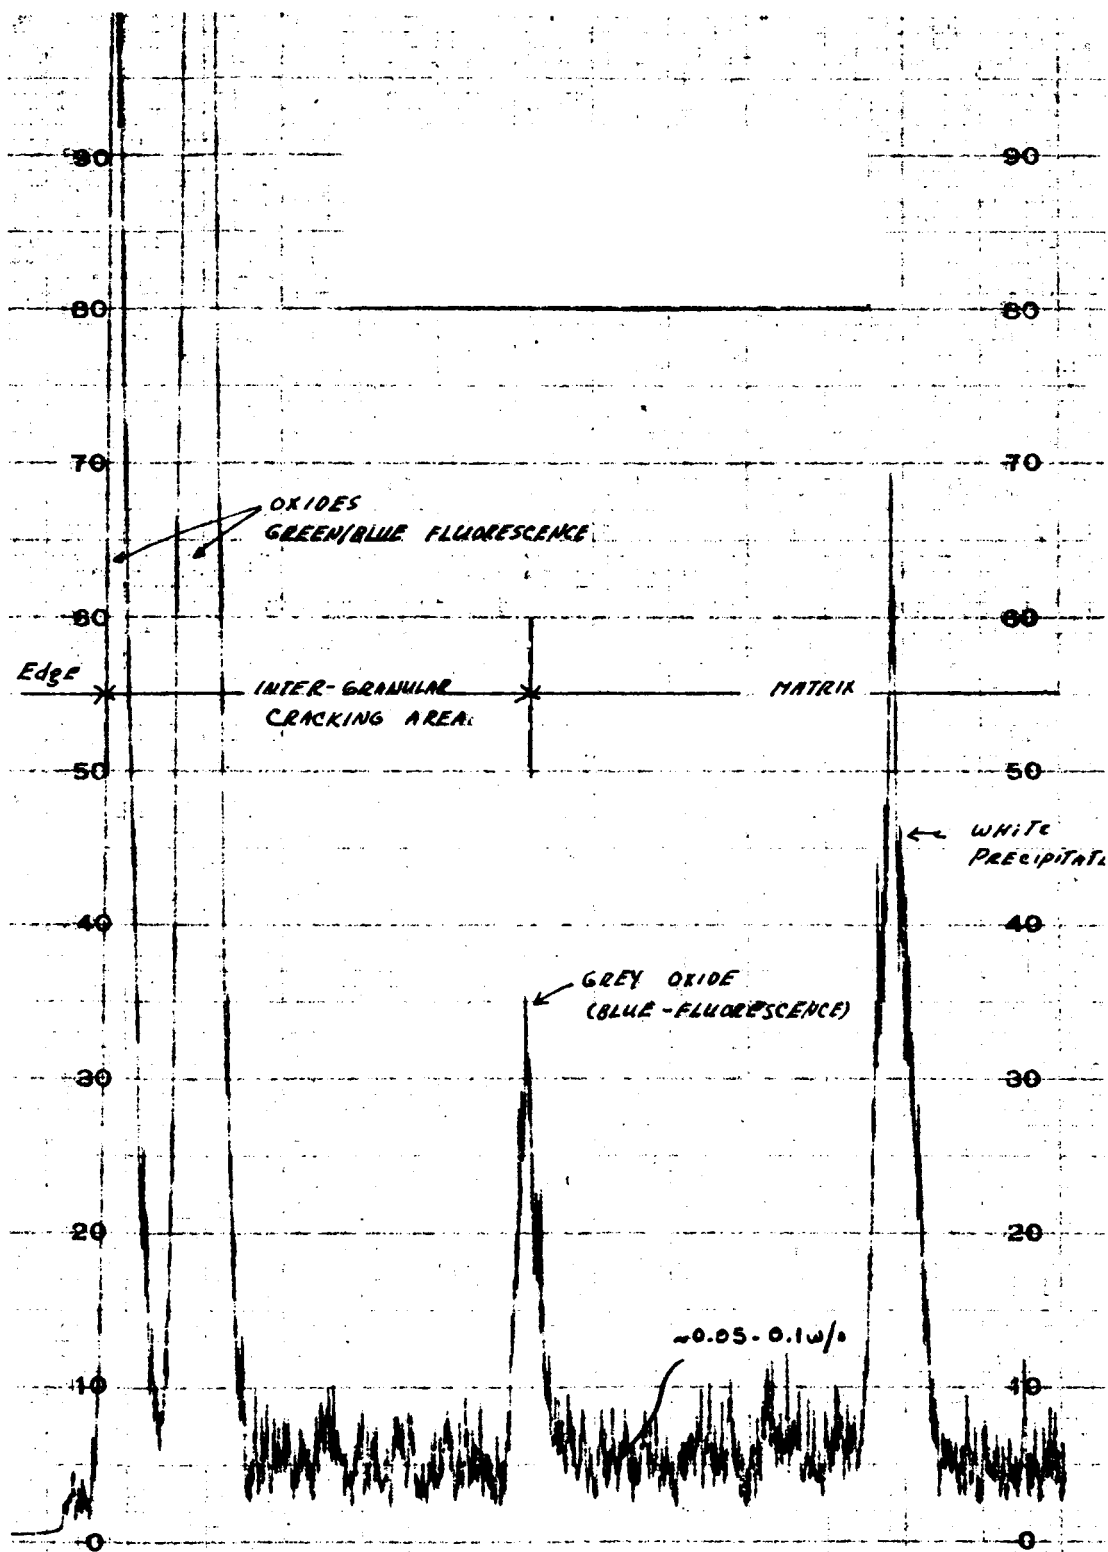
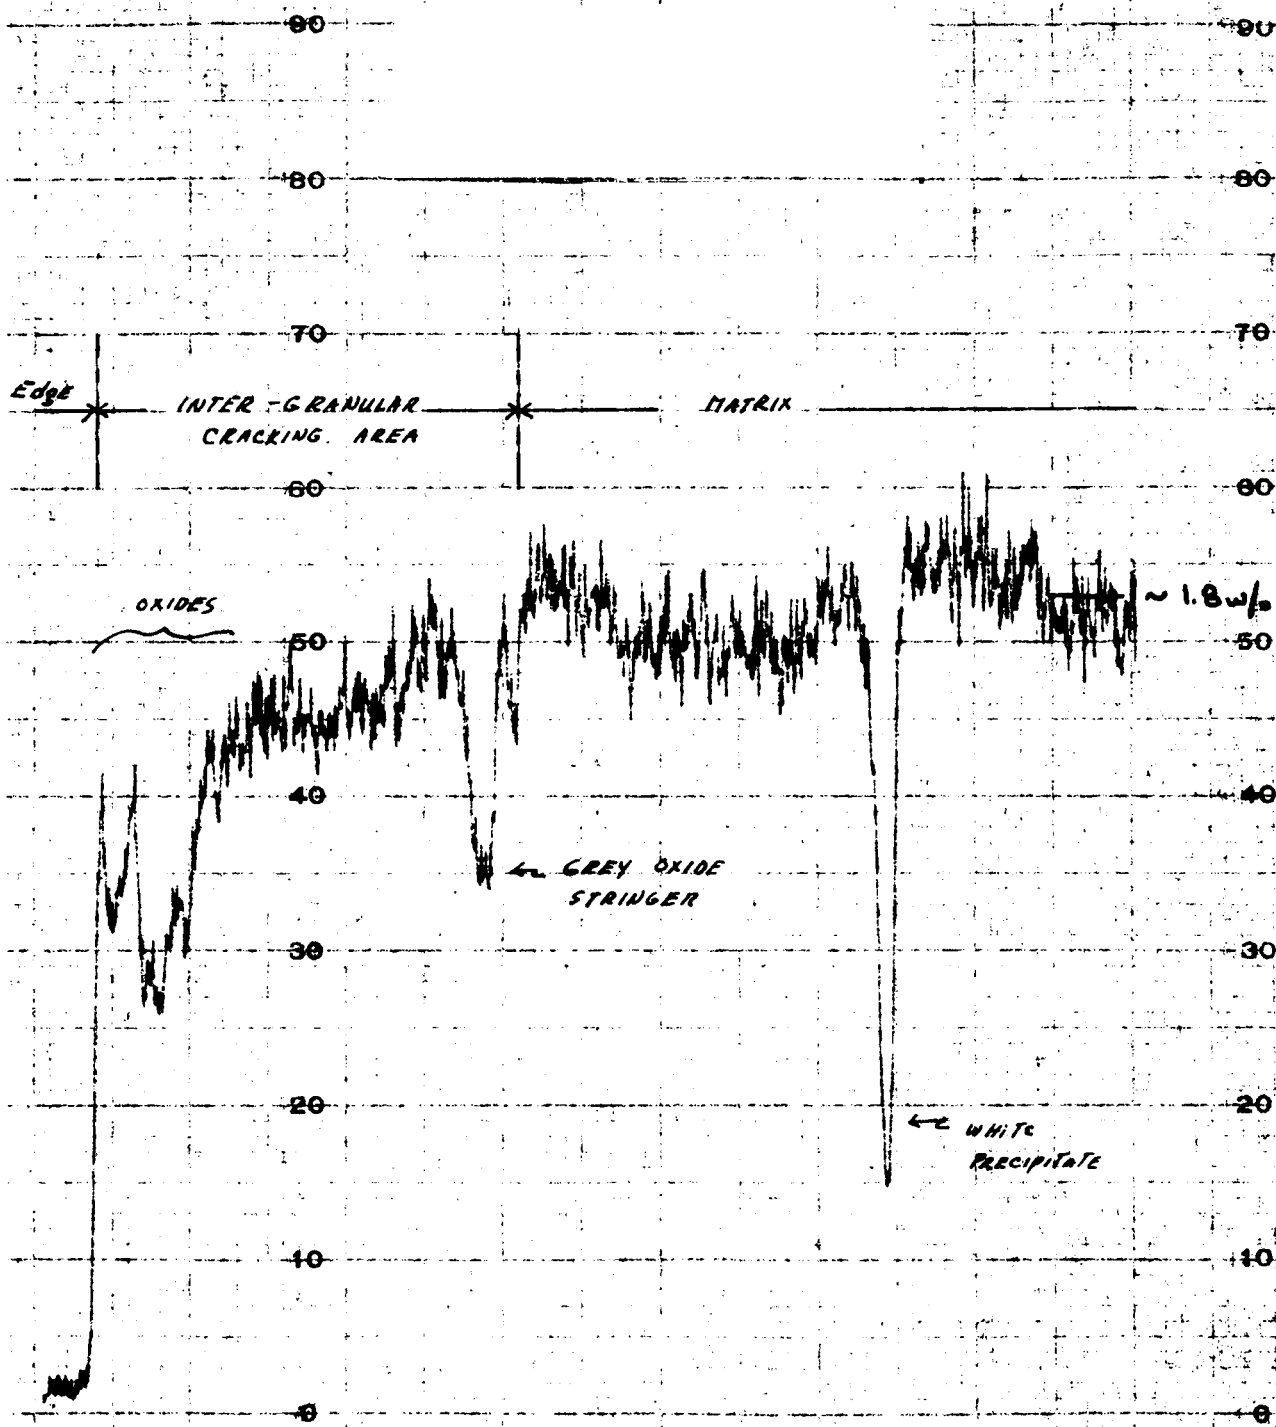
Examination of the nozzle throat specimen (see Figure 27b) revealed a surface zone of intergranular precipitation extending to a depth of approximately 70 microns. A series of large gray precipitates near the base metal-end of the surface zone were also noted. The gray phases and oxides were found to be zirconium oxides that appeared to also contain some nickel in solution. These phases were identified as oxides since they yielded a visible fluorescence when struck by the electron beam. This fluorescence is typical of the presence of combined oxygen. The composition of the metal matrix surrounding the oxides was found to be essentially the same as the base metal. The concentration distributions for chromium and tungsten were consistent at less than 0.05 percent.
